MISCELLANEOUS PAPER S-65-27

MISSILE BASES: DESIGN AND CONSTRUCTION PROBLEMS

December 1968

U. S. Army Engineer Waterways Experiment Station
CORPS OF ENGINEERS
Vicksburg, Mississippi

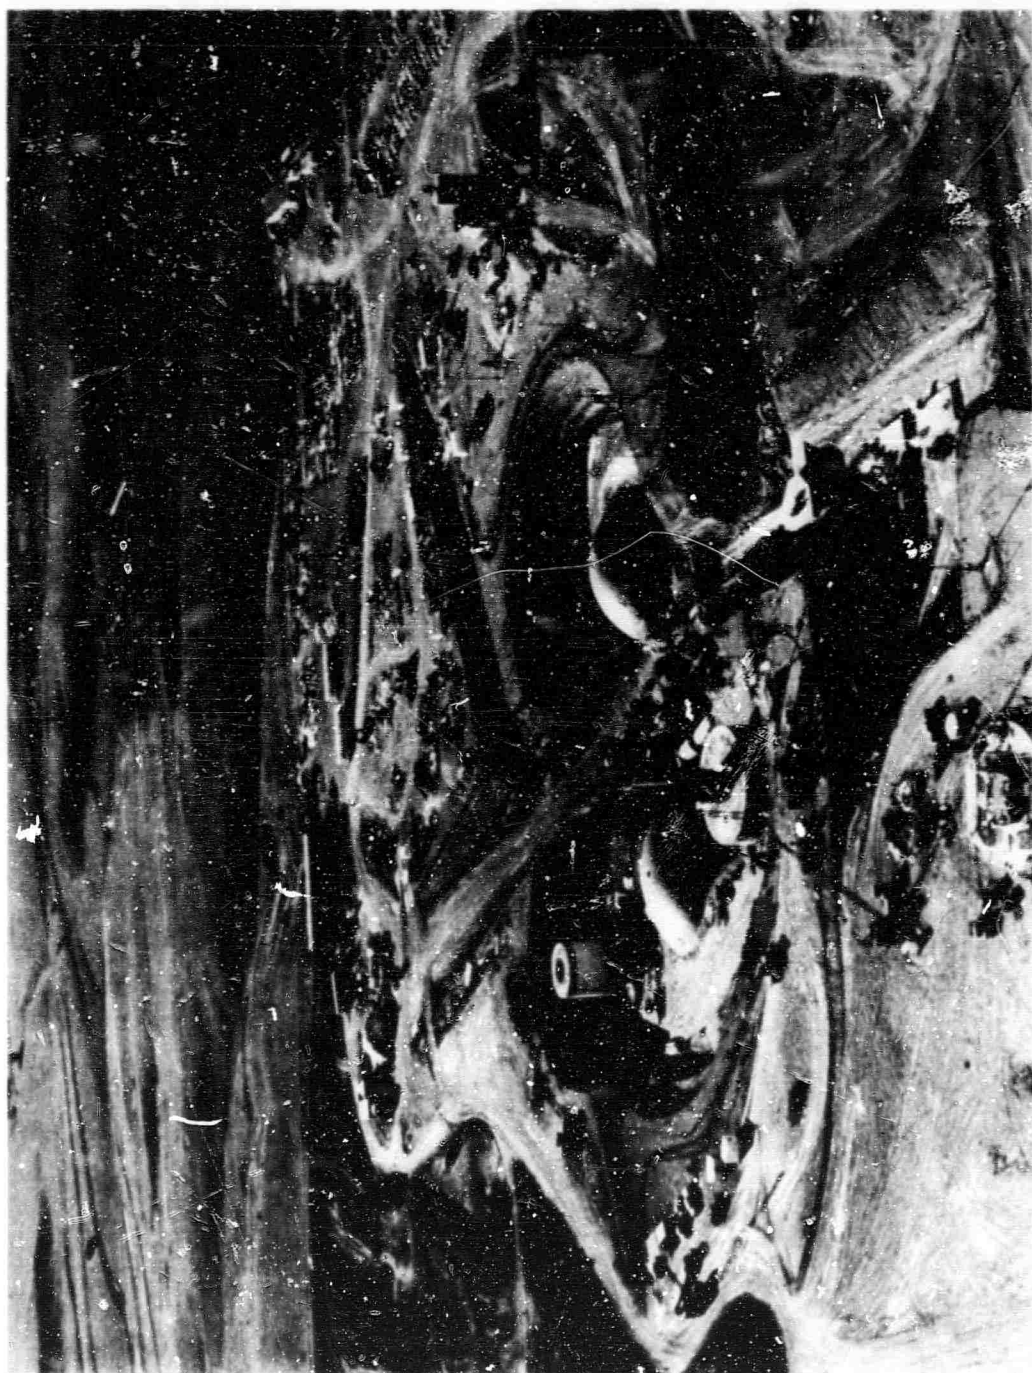
Fig. 1. Aerial view of Titan I complex

In order to gain a better idea of missile-base construction work, some illustrations are included which demonstrate why rather severe problems in design and/or construction developed. Figure 1 is an aerial view of a Titan I complex. The view shows the structures partially backfilled, and illustrates the steep back slopes and the relatively confined construction area involved. Figure 2 is a cutaway of the Atlas F configuration showing the location of the major features of construction with respect to the ground surface. Figure 3 is a cutaway of a Minuteman launch facility showing the relation of the launch equipment room (LER) (doughnut-shaped structure around the missile shaft), access shaft (AS), and launch equipment building (LEB). It will be noted that very little

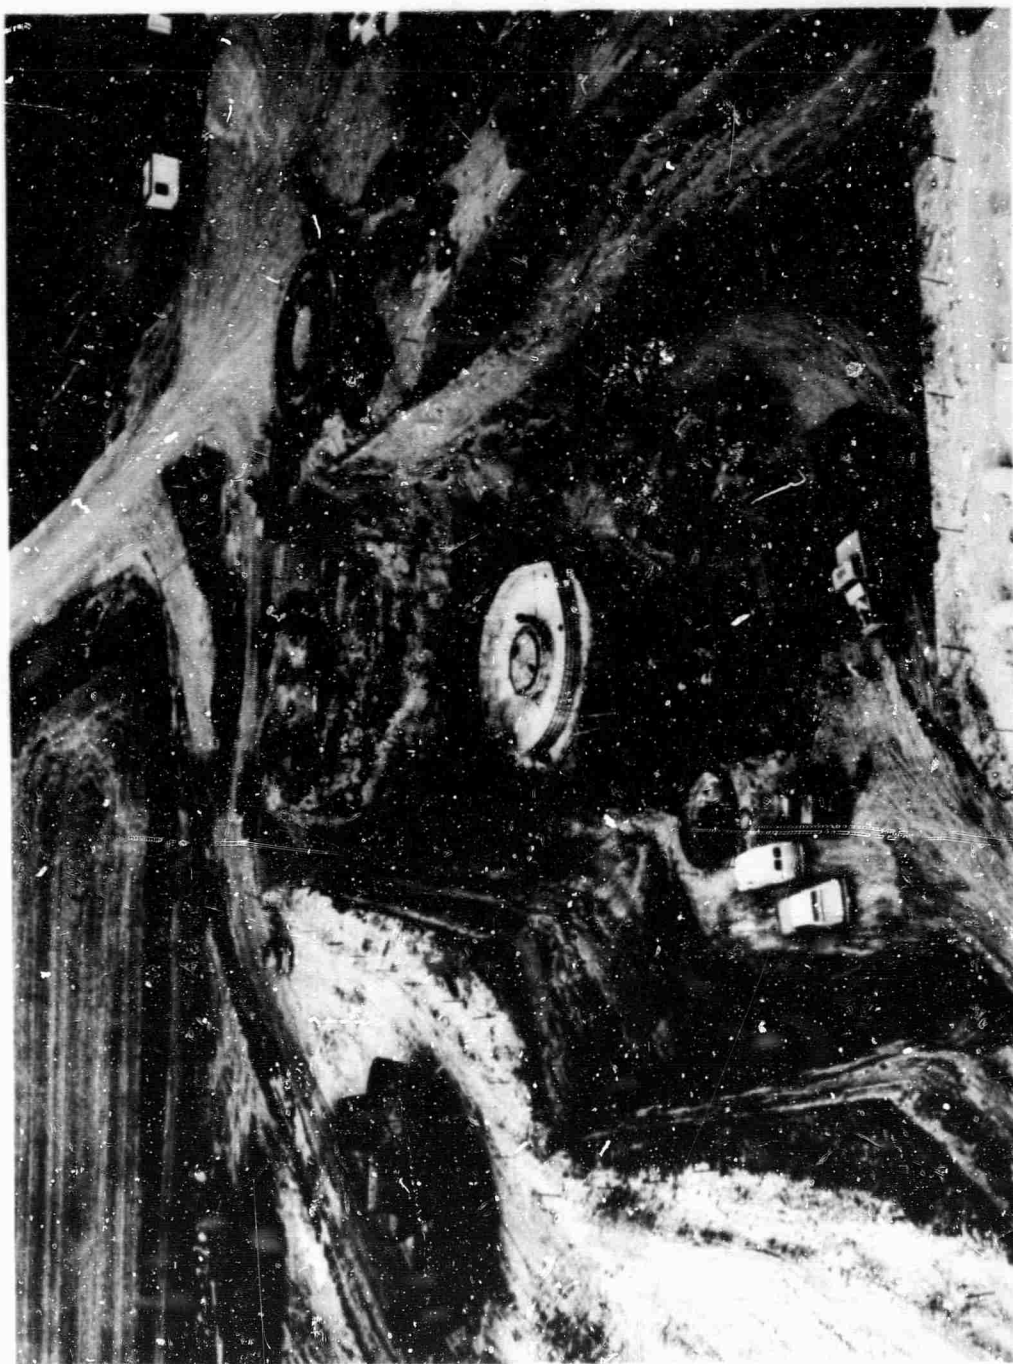
Fig. 9. Minuteman excavation; wet base-level due to seepage from toe of slope

Excavation. The lack of adequate plans and specifications for individual facilities, as far as excavating and dewatering were concerned, can be considered as the basic cause of many difficulties. Excavation, in general, both in open cut and shaft, posed relatively few problems except in those sites where unanticipated difficulties were produced by groundwater or where improper blasting techniques were used. It was the exception rather than the rule for groundwater problems to be properly evaluated in advance of construction and for proper construction techniques to be utilized to avoid difficulty. In fact, at numerous facility sites, it was not possible to develop proper construction techniques due to the absence of a properly designed and installed dewatering system. Improper handling of groundwater resulted in sloughing of slopes that were excavated too steep; development of high pore pressures in cohesionless materials around shafts, causing excessive lateral pressures and sometimes outright failures; slippage of rock, shale blocks, and soil into shafts; and development of quick conditions in areas being excavated due to seepage into the completed excavation. Figure 7 shows an Atlas facility with excavation to the basic level; water problems are being experienced from runoff into the excavation and from seepage at the toe of the excavation. Figure 8 is a view looking into an Atlas F silo showing a wet, mucky condition at the bottom of the excavation. Figures 9, 10, 11, and 12 are views of Minuteman excavations. Figure 9 shows a wet base-level excavation due to seepage from the toe of the slope. Figure 10 shows water piping from the toe of the excavation and sloughing soil. Figure 11 shows the completed excavation for an LEB structure, the bottom of which has become liquefied due to upward seepage. Figure 12 shows

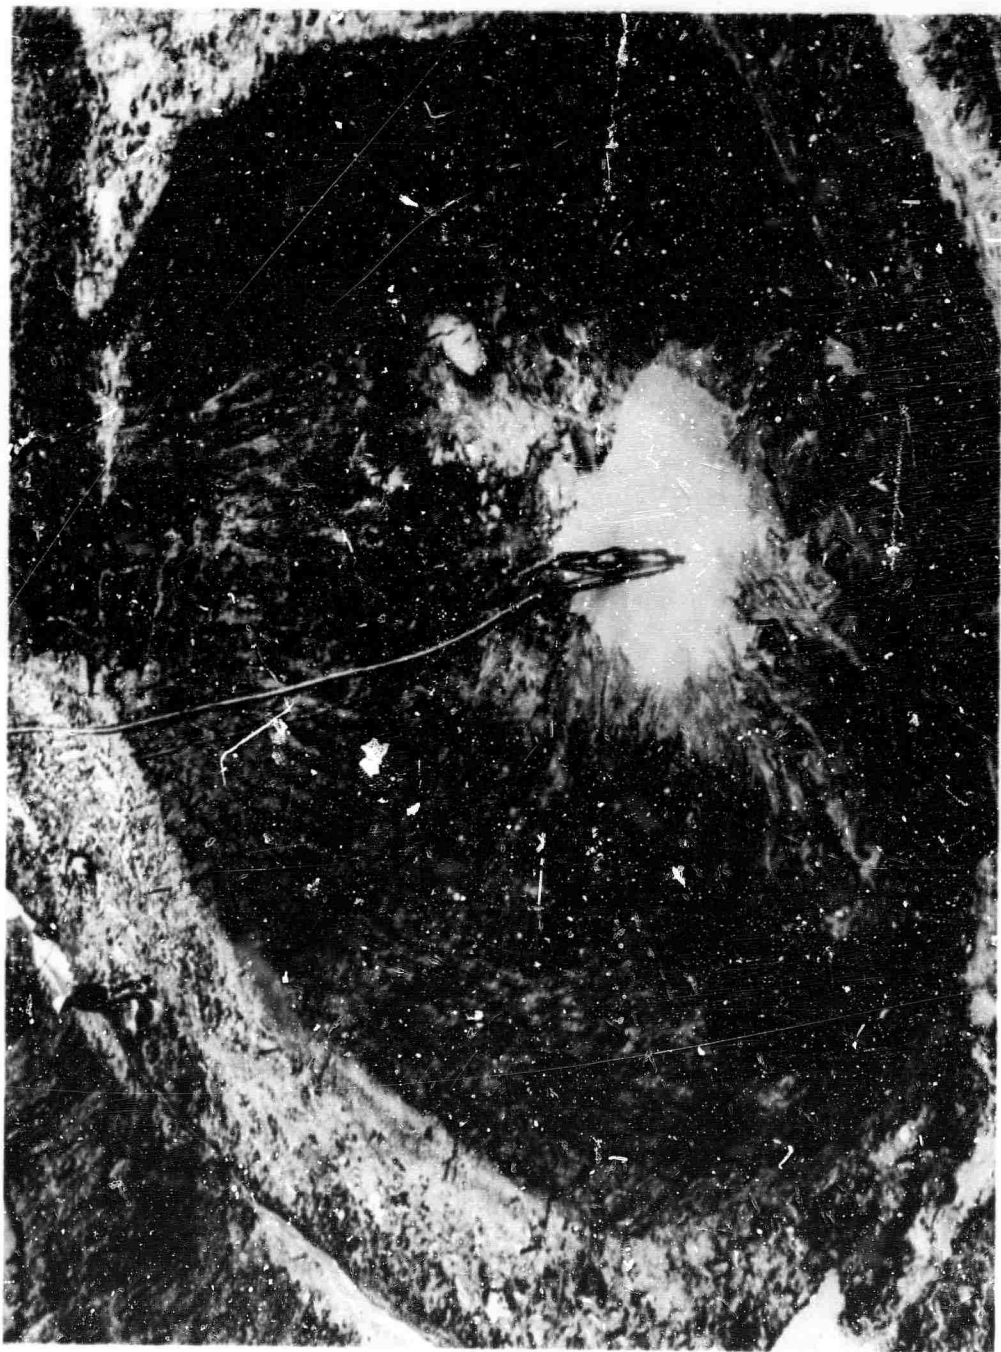
Fig. 11. Completed excavation for Minuteman launch equipment building

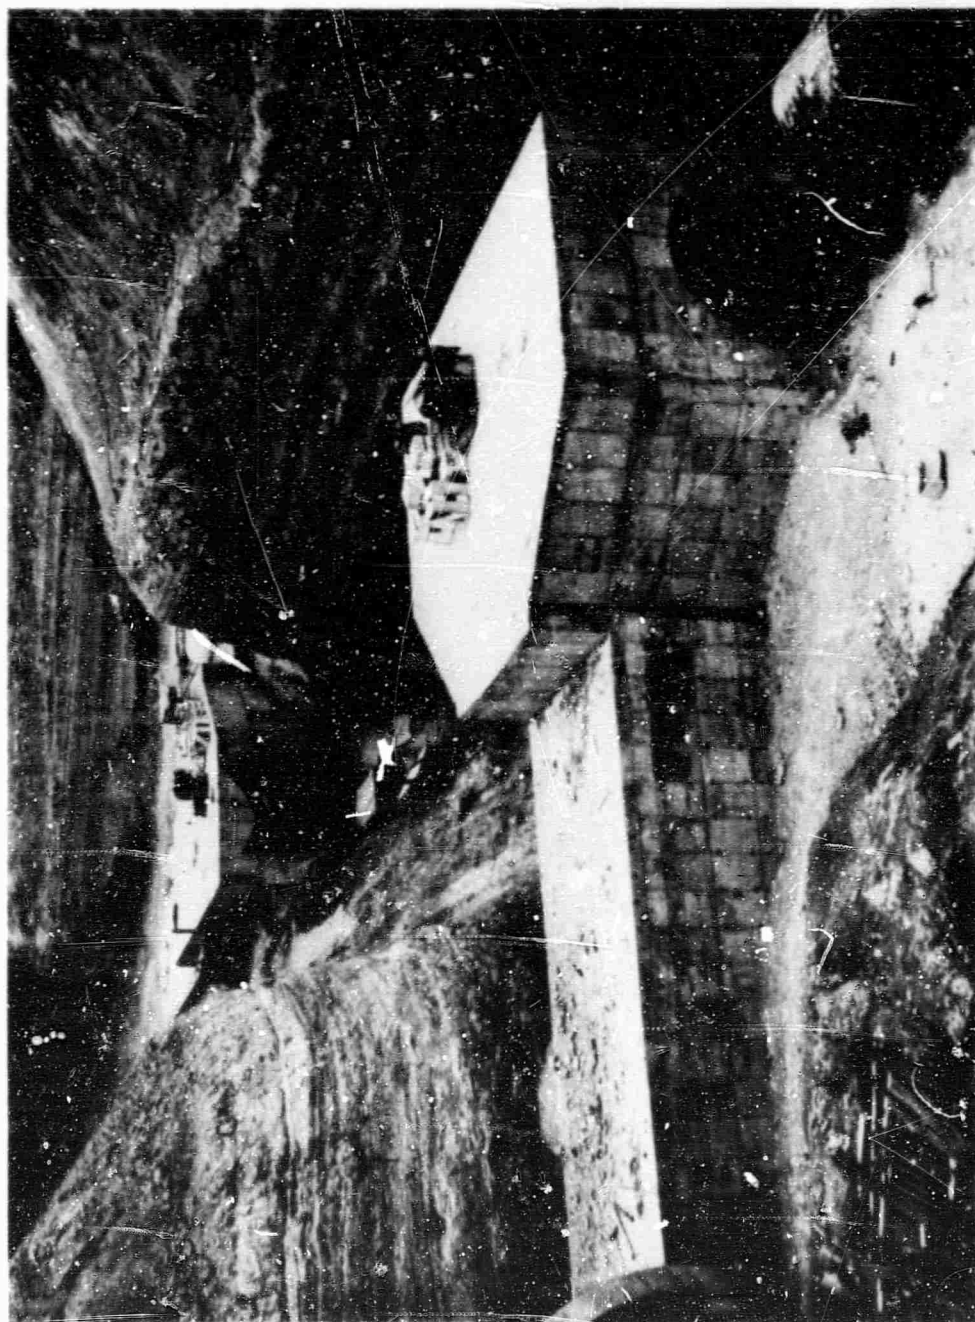
Fig. 13. Backfill around concrete blastlock structure and below haunch of steel-plate tunnel, Titan I facility
